# Inspection Report

**Bob and Suzy Smith**  
**123 Main Street**  
**Anywhere, OH 44747**

*Inspected by:* **John A. Dragomier**

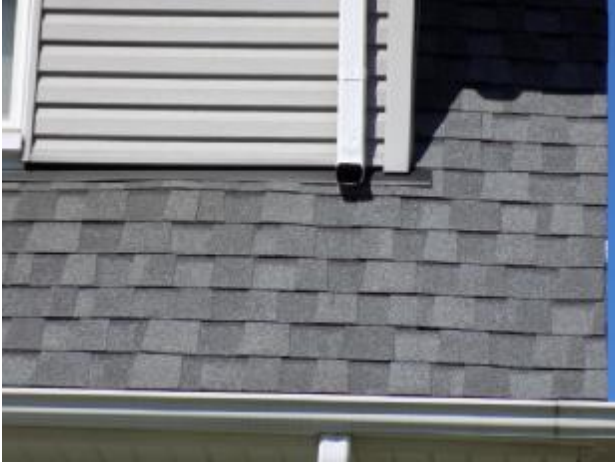
**#R1**

1. Gutter extension is missing on the front corner of second story. This will allow for premature aging of the shingles. Recommend a reputable contractor. (see photo 01).

**Missing gutter extension**

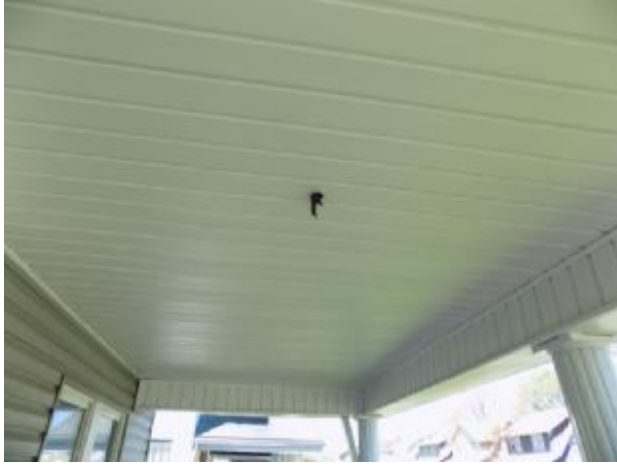
**#EX1**

1. **SAFETY HAZARD** - There are bare wires hanging from the porch ceiling. This can lead to electrical shock or worse. Recommend a reputable licensed electrical contractor. (see photo 01).

**Bare wires on porch roof**

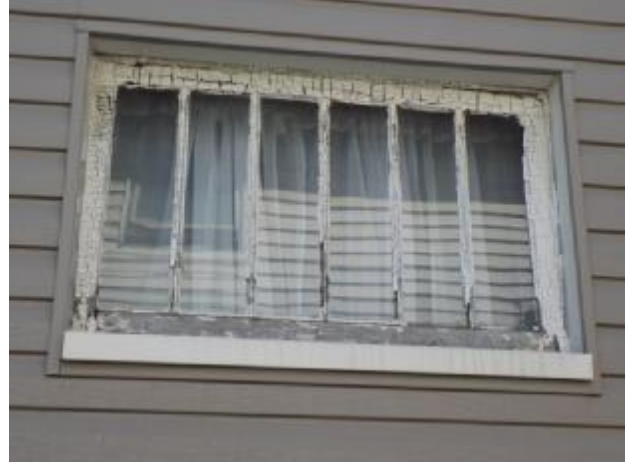
**#EX2**

2. Wooden windows on the left and back of the house have chipped and peeling paint. This will lead to early deterioration of the window. Recommend a reputable contractor. (see photo 02).

**Chipped & peeling paint**

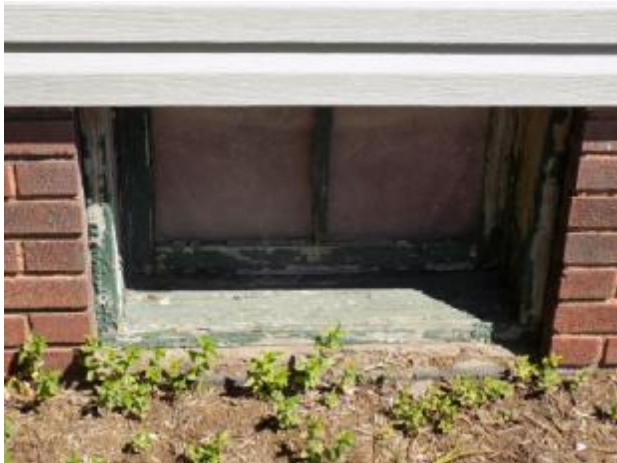
**#EX3**

3. All basement windows are wooden and have chipped & peeling paint. This will lead to early deterioration of the window. Recommend a reputable contractor. (see photo 03).

**Chipped & peeling paint**

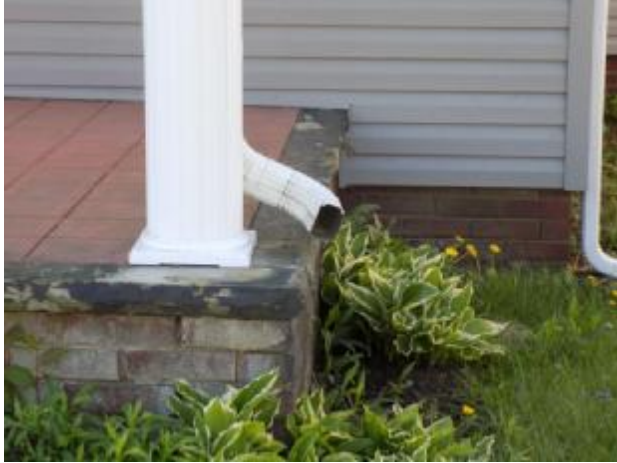
**#GD1**

1. The down spouts should extend three feet from the house. If they drain near the foundation it can lead to water intrusion. Recommend a reputable contractor. (see photo 01).

**Down spouts need extended**

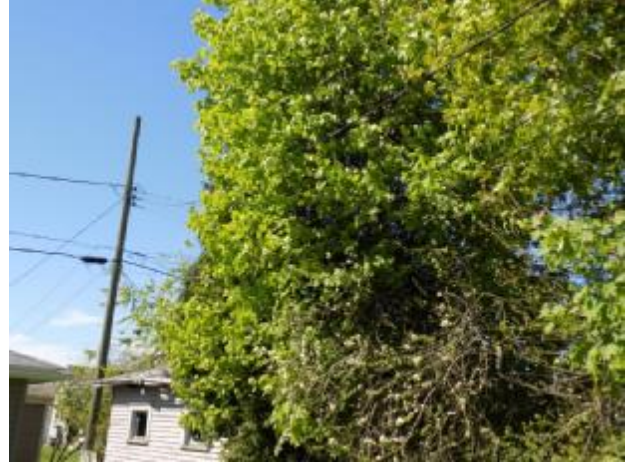
**#GD2**

2. **SAFETY HAZARD** - The trees are growing too close to the power lines. This can cause the lines to be torn from the house and cause electrical shock or worse. Recommend a reputable contractor. (see photo 02).

**Tree limbs on service drop**

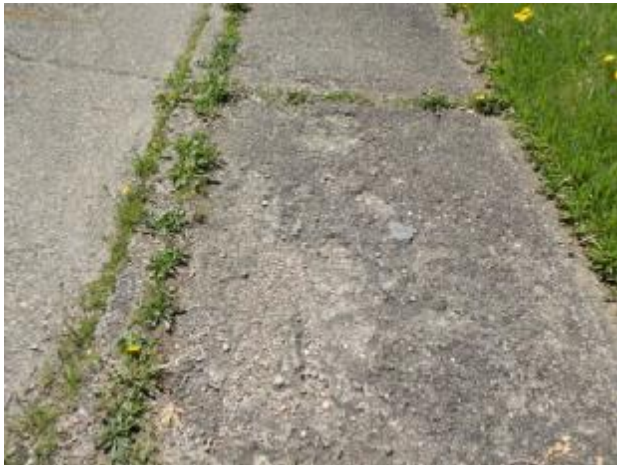
**#GD3**

3. **SAFETY HAZARD**- The sidewalks at the front and side of the house are cracked and crumbling. This is a trip hazard. Recommend a reputable contractor. (see photo 03).

**Crumbling sidewalks**

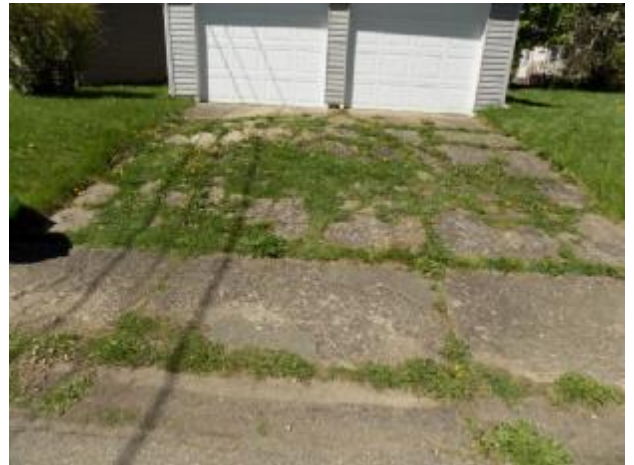
**#GD4**

4. **SAFETY HAZARD**- The driveway is cracked and crumbling. This is a trip hazard. Recommend a reputable contractor. (see photo 04).

**Cracked driveway**

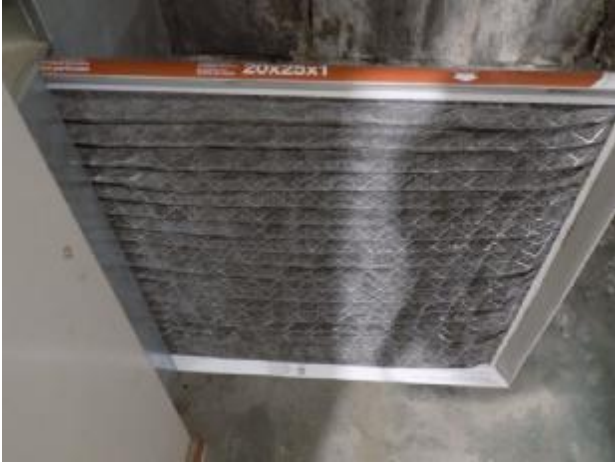
**#HC1**

1. The furnace filter is dirty. This will cause the unit to run inefficiently. Recommend replacing. (see photo 01).

**Dirty filter**

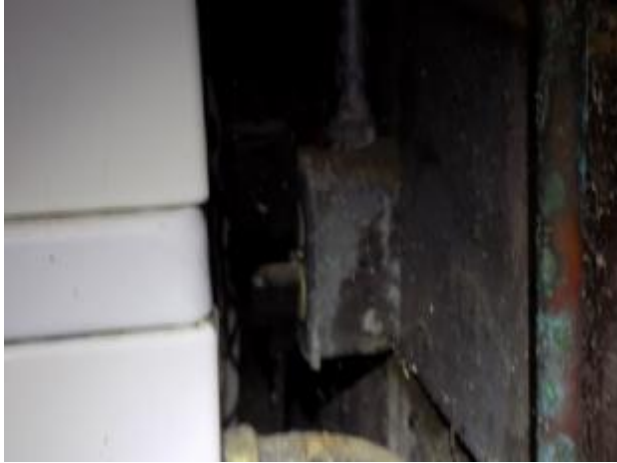
**#EL1**

1. **SAFETY HAZARD** - There is no GFCI outlet behind the washing machine in the basement. This can cause electrical shock or worse. Recommend a reputable licensed electrical contractor. (see photo 01).

**Missing GFCI**

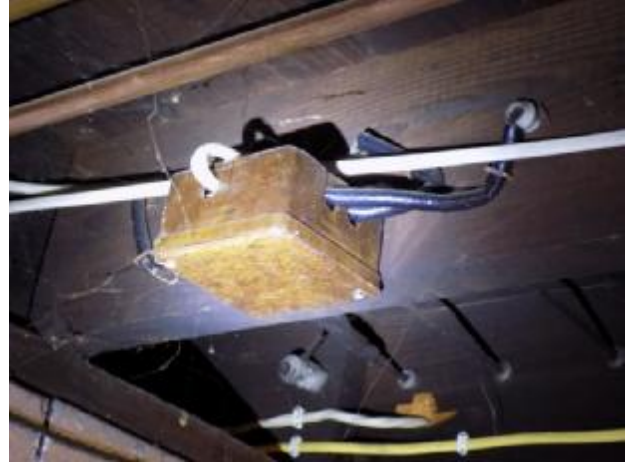
**#EL2**

2. **SAFETY HAZARD** - There is evidence in the basement that knob and tube wiring has been spliced into romex wiring. This can cause a fire. Recommend a reputable licensed electrical contractor. (see photo 02).

**Knob and tube spliced to romex**

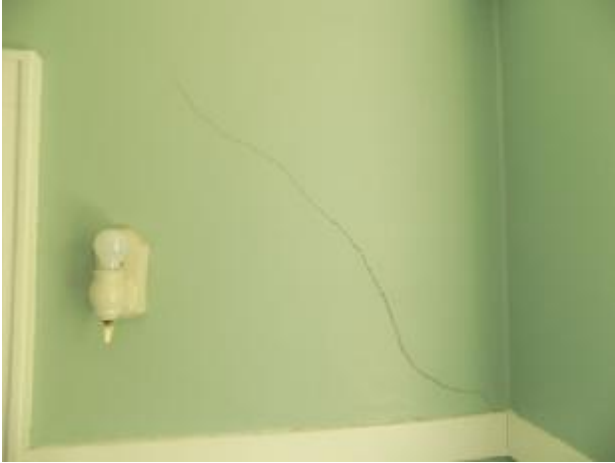
**#B1**

1. There is a settling crack on the bathroom wall. This is normal due to the age of the home. Recommend repairing (see photo 01).

**Settling crack**

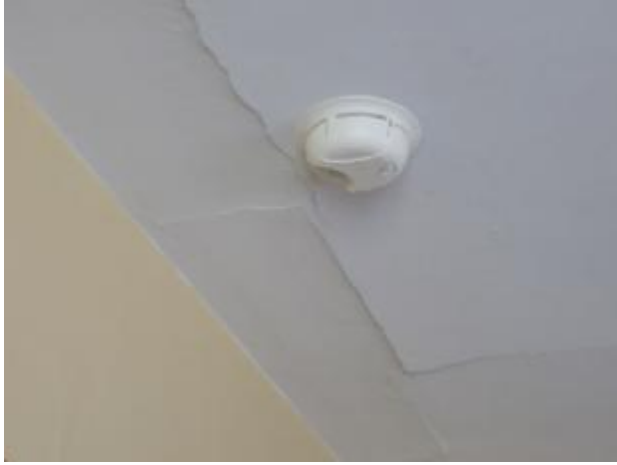
**#IR1**

1. The dining room ceiling has a settling crack. This is normal due to the age of the home. Recommend a reputable

**Settling crack**

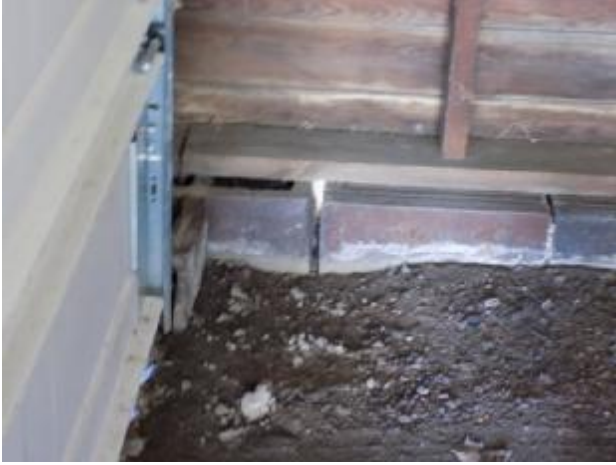
**#GC1**

1. This garage has dirt floors which can lead to moisture problems with the framing. Also there is a separation gap in the foundation which can lead to water intrusion. Recommend reputable contractor. (see photo 01).

**Foundation separation**

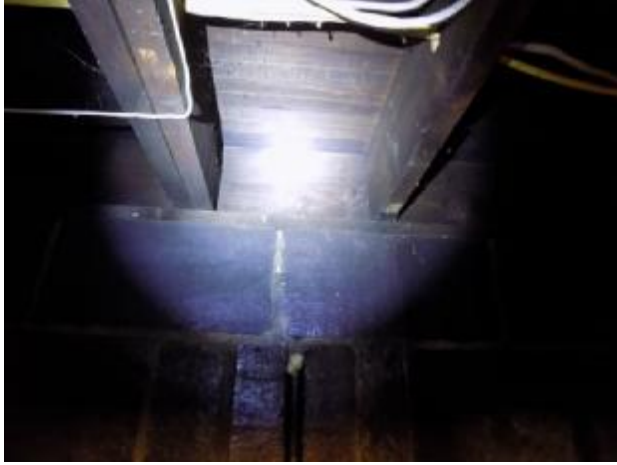
**#F1**

1. There is no insulation in the foundation framing. This will lead to inadequate heating and cooling. Recommend adding insulation. (see photo 01).

**Missing insulation**

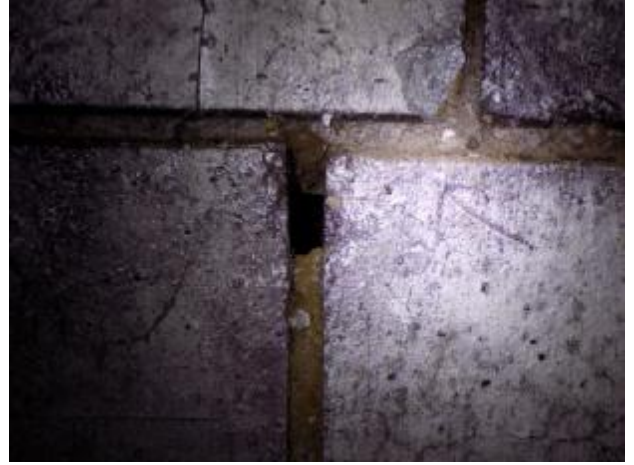
**#F2**

2. Several areas on the east wall of the basement have missing mortar. This will lead to water intrusion. Recommend filling with concrete caulking. (see photo 02).

**Missing mortar**

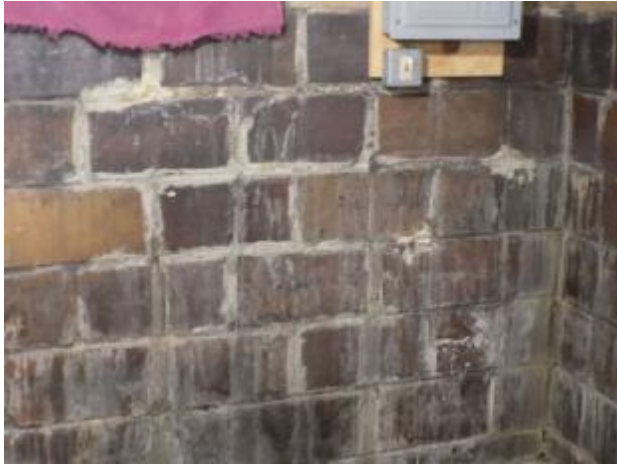
**#F3**

**Water intrusion**
